SockFix grouted anchors provide lateral restraint

Client: Private homeowners

Location: South Wales

Consultants: Helifix

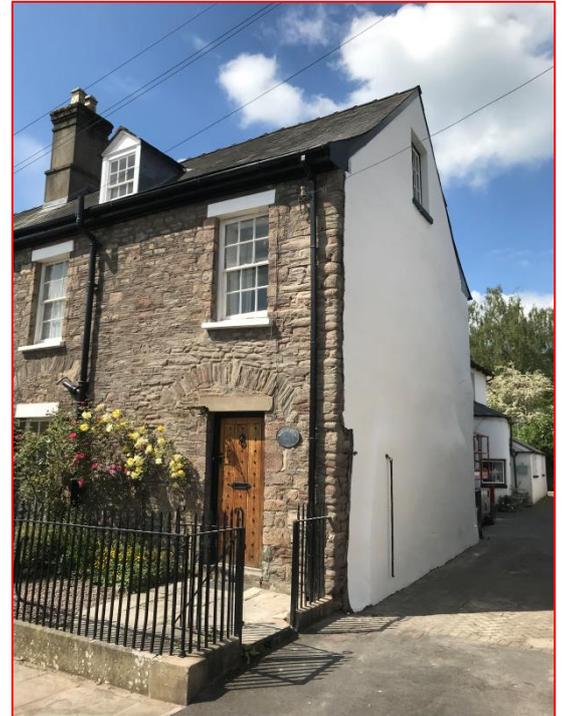
This Grade II listed, semi-detached, period cottage has some original elements dating back to the 16th century. With 450mm thick rubble-filled stone walls, it was suffering from outward movement of the gable end wall causing internal cracking along the ceiling lines at first and second floor levels as well as cracking in the front elevation over the front door entrance.

The wall, which had suffered from historic substance, had a lack of lateral restraint as there was no internal cross wall to supply a tie in, parallel joists at first and second floor levels gave no restraint and an 'archway' link to the neighbouring property, that provided buttress support, had previously been removed.

Helifix engineers designed repairs using 80m of stainless steel HeliBars and 16 x 1.5m SockFix grouted anchors. Installation had to be carried out from a mobile platform so that the access remained open.

- Deep masonry beams were created across the full width of the gable wall by bonding pairs of stainless steel HeliBars into slots cut above and below the first and second floor joists. These stabilised and reinforced the masonry and the one at first floor level was continued around the front of the house to address the cracking over the door.
- Individual HeliBars were installed, between the Helibeams, around the front elevation gable wall corner, to stitch cracks.
- SockFix stainless steel anchors were inserted into clearance holes drilled into both the Helibeams, through the rubble-filled wall and the first two parallel floor joists. They were then filled with HeliBond cementitious grout, filling any voids, expanding between the joists and forming a strong chemical /mechanical bond.
