SockFix grouted anchors provide lateral restraint

Client: Private homeowners

Location: South Wales

Consultants: Helifix

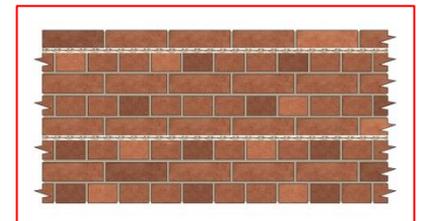
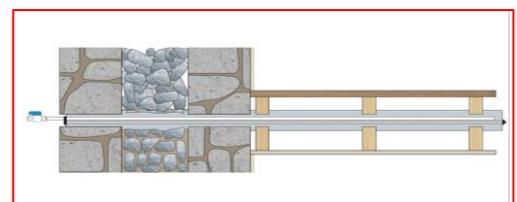
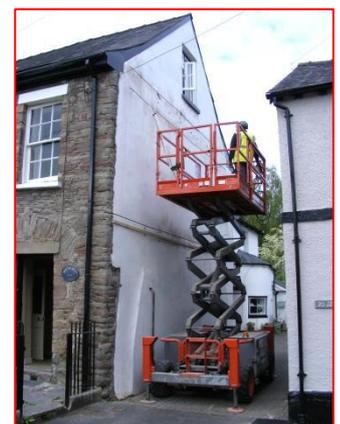
This Grade II listed, semi-detached, period cottage has some original elements dating back to the 16th century. With 450mm thick rubble-filled stone walls, it was suffering from outward movement of the gable end wall causing internal cracking along the ceiling lines at first and second floor levels as well as cracking in the front elevation over the front door entrance.

The wall, which had suffered from historic substance, had a lack of lateral restraint as there was no internal cross wall to supply a tie in, parallel joists at first and second floor levels gave no restraint and an 'archway' link to the neighbouring property, that provided buttress support, had previously been removed.

Helifix engineers designed repairs using 80m of stainless steel HeliBars and 16 x 1.5m SockFix grouted anchors. Installation had to be carried out from a mobile platform so that the access remained open.

- Deep masonry beams were created across the full width of the gable wall by bonding pairs of stainless steel HeliBars into slots cut above and below the first and second floor joists. These stabilised and reinforced the masonry and the one at first floor level was continued around the front of the house to address the cracking over the door.
- Individual HeliBars were installed, between the Helibeams, around the front elevation gable wall corner, to stitch cracks.
- SockFix stainless steel anchors were inserted into clearance holes drilled into both the Helibeams, through the rubble-filled wall and the first two parallel floor joists. They were then filled with HeliBond cementitious grout, filling any voids, expanding between the joists and forming a strong chemical /mechanical bond.
